# When "Skyhooks" Are Not Available

by M.J. Chow, P.E., and T. Popoff, P.E.

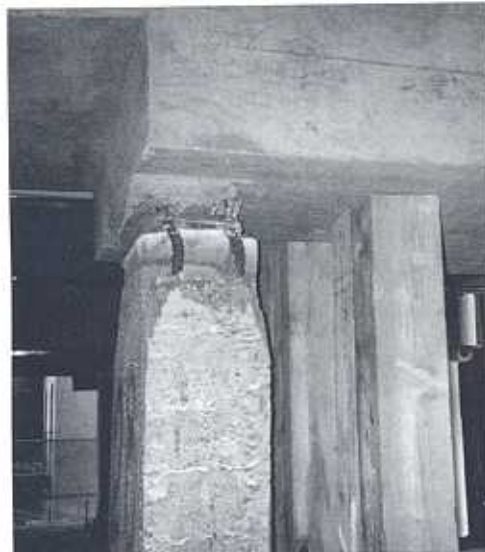
Construction for a 23-story midtown residential tower proceeded smoothly until the roof was poured. A group of five 7th floor columns then failed under the dead load of the over-lying 16 floors and roof. The damaged columns rotated and crushed, resulting in column shortening of as much as three inches and up to two inches of lateral movement (photo 1). All work stopped and temporary emergency shoring was

Photo 1: Column damage included buckled reinforcing bars.

crete found to be weaker than specified had spalled, exposing buckled steel reinforcing bars at the columns with the most damage. The remaining 7th floor columns were intact and judged safe. Contract drawings were reviewed and column design loads obtained from the structural engineer of record.

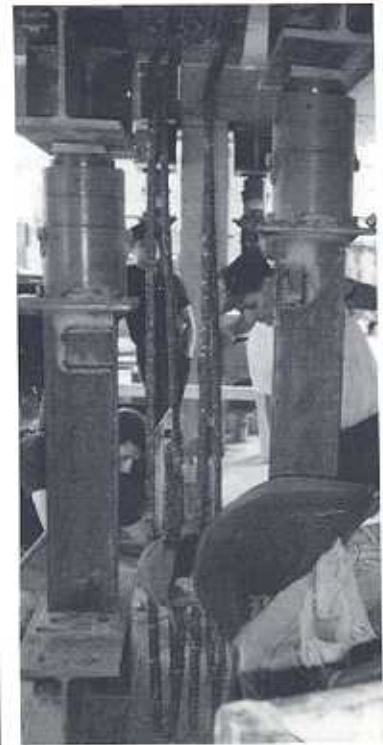
Photo 2: Transfer beam/jacking post system.

sound portions of the existing structure as support for the steel jacking frames. Steel posts and hydraulic jacks were set between steel load transfer beams to carry loads of 300 tons around the damaged part of each column to sound structural members. Damaged portions of the columns were removed after the loads were jacked onto the transfer beam/jacking post system (photo 2).

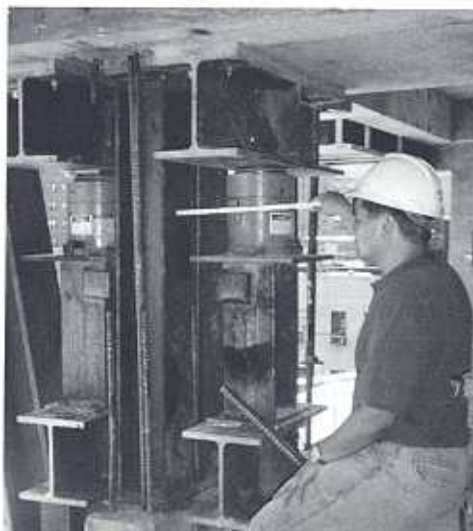
Photo 3: Checking placement of hydraulic jack.

Two different repair schemes were developed to replace the damaged concrete. At two columns, as much as eight inches of damaged concrete was removed and replaced with 5000 psi concrete. At the three other columns, where a few feet of damage had occurred, the damaged concrete was removed and replaced by steel columns (photo 3). The

replacement steel columns were then-encased in concrete.
